**Flood Control Project Maintenance
Levee Inspections****LMA District Cover Sheet****Spring 2016 Levee Inspection Results****Tehama County Flood Control and Water Conservation District**

**Flood Control Project Maintenance
Levee Inspections**

Spring 2016 Levee Inspection Results

Tehama County Flood Control and Water Conservation District

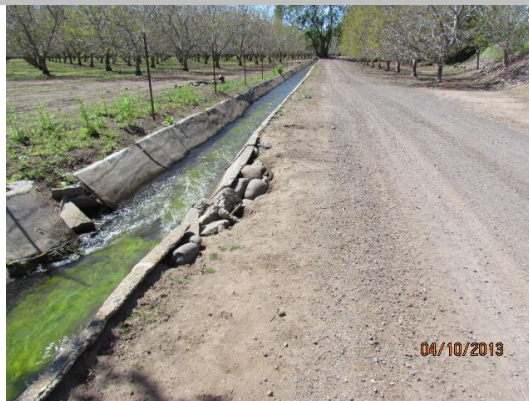
Photo 1 of 1 : SP_2016_NA0019_78_41_20160513_00061.jpg

LM Start	0.00	Rating **	U	Issue No.	41
LM End	0.65	Issue Type +	En	Location *	LS
Category	Earthen Levee			GPS Latitude/Longitude	
				Start	End
Item	Encroachments			39.973077 °	39.971722 °
				-121.980344 °	-121.991869 °
DWR ID	DWR_NA0019_01_s _ 2016_41				
Comment Code					
DT : Ditch					
Inspector Comment					
Concrete-lined ditch on L/S.

Concrete-lined ditch along L/S.

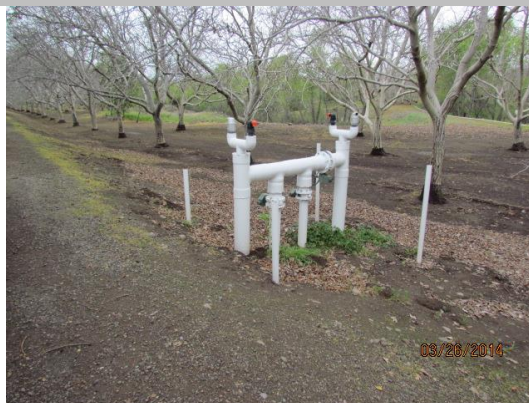
Photo 1 of 1 : SP_2016_NA0019_78_275_20160316_00017.jpg

LM Start	0.02	Rating **	U	Issue No.	275
LM End	0.02	Issue Type +	En	Location *	WS
Category	Earthen Levee			GPS Latitude/Longitude	
				Start	End
Item	Encroachments			39.973128 °	39.973128 °
				-121.980734 °	-121.980734 °
DWR ID	DWR_NA0019_01_s _ 2014_275				
Comment Code					
PI : Pipe					
Inspector Comment

View of the irrigation pipe along the waterside slope.

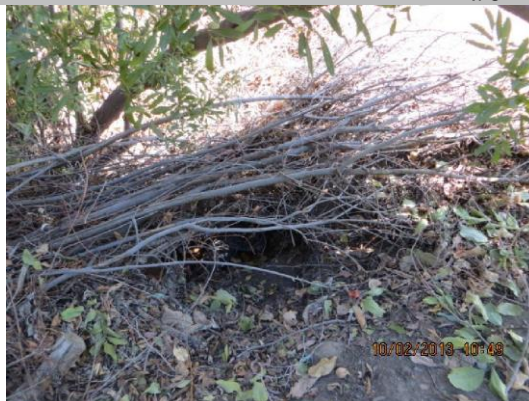
Photo 1 of 2 : UCIP_SP_2016_39840_39060.jpg

LM Start	0.17	Rating **	M	Issue No.	288
LM End	0.17	Issue Type +	En	Location *	WS
Category	Supplemental			GPS Latitude/Longitude	
				Start	End
Item	DWR UCIP Field Study			39.973302 °	39.973302 °
				-121.983538 °	-121.983538 °
DWR ID					
Comment Code					
Inspector Comment					
FS_ID:39840 DS_ID:24684 EP_NO: N/A Repair Type: Non-Urgent Crossing Status: Found UCIP Comments: No permit identified for this crossing. FIELD_STRUCT_DESC: 36-inch concrete irrigation pipe through the levee 0.5-feet below the crown. Concrete canal and distribution struture on LS shoulder. FS Date: 10/2/2013

Outlet covered by tree trimmings.

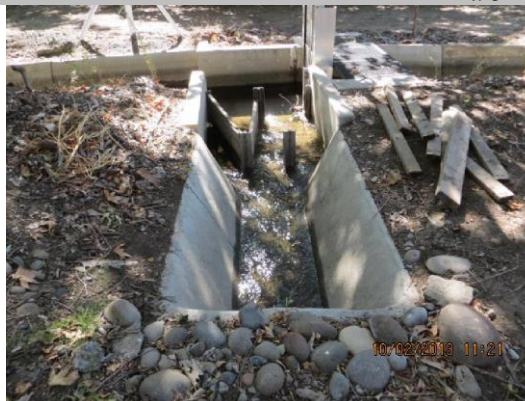
Photo 1 of 2 : UCIP_SP_2016_39839_39063.jpg

LM Start	0.49	Rating **	M	Issue No.	291
LM End	0.49	Issue Type +	En	Location *	LS
Category	Supplemental			GPS Latitude/Longitude	
				Start	End
Item	DWR UCIP Field Study			39.972280 °	39.972280 °
				-121.989227 °	-121.989227 °
DWR ID					
Comment Code					
Inspector Comment					
FS_ID:39839 DS_ID:24686 EP_NO: N/A Repair Type: Non-Urgent Crossing Status: Found UCIP Comments: No permit identified for crossing. FIELD_STRUCT_DESC: 20-inch concrete irrigation pipe through the levee 2-feet below the crown. Concrete canal and distribution struture with slat boards on LS shoulder. FS Date: 10/2/2013

Concrete canal/distribution box on LS shoulder.

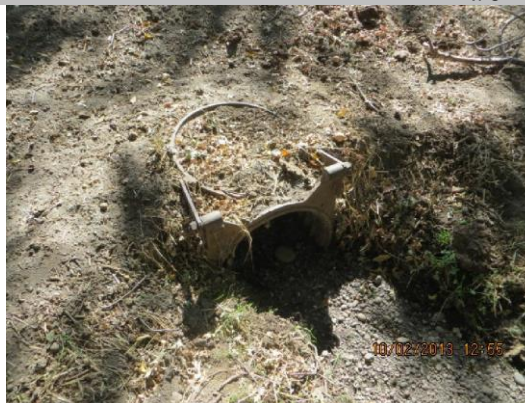
Photo 1 of 2 : UCIP_SP_2016_21729_36922.jpg

FS_ID:21729
DS_ID:20770
EP_NO: N/A
Repair Type: Urgent
Crossing Status: Found
UCIP Comments: Flapgate blocked by soil buildup.
FIELD_STRUCT_DESC: 24-inch pipe through the levee 1.5-feet below the crown. Flap gate on the WS toe. Originally included in O+M manual (1957). As-built drawings available 50-4-2394.
FS Date: 10/2/2013

Flapgate on WS toe.

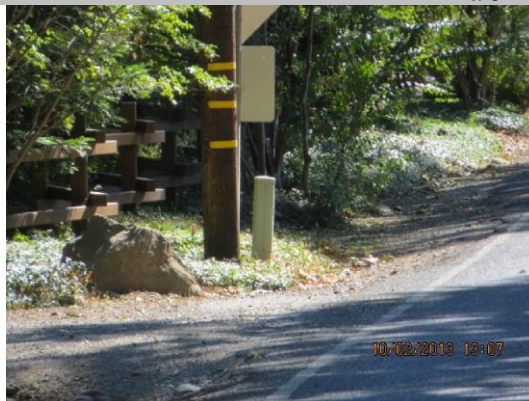
Photo 1 of 2 : UCIP_SP_2016_39837_39067.jpg

FS_ID:39837
DS_ID:24690
EP_NO: N/A
Repair Type: Non-Urgent
Crossing Status: Found
UCIP Comments: No permit identified for this crossing.
FIELD_STRUCT_DESC: 4-inch steel conduit through the levee at an unknown depth. Junction box off LS toe next to JP and roadway.
Conduit visible on upstream side of bridge at Deer Creek crossing.
FS Date: 10/2/2013

Communication box off LS shoulder next to roadway.

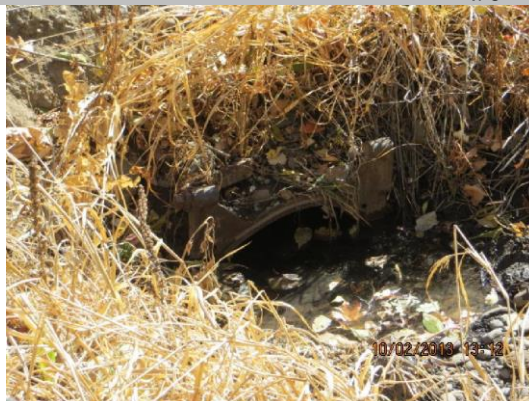
Photo 1 of 2 : UCIP_SP_2016_21730_36925.jpg

LM Start	1.89	Rating **	U	Issue No.	279
LM End	1.89	Issue Type +	En	Location *	WS
Category	Supplemental			GPS Latitude/Longitude	
				Start	End
Item	DWR UCIP Field Study			39.969105 °	39.969105 °
				-122.014028 °	-122.014028 °
DWR ID					
Comment Code					
Inspector Comment					
FS_ID:21730 DS_ID:20769 EP_NO: N/A Repair Type: Urgent Crossing Status: Found UCIP Comments: Flapgate missing or burried on WS toe. Pipe partially blocked by soil on WS toe. FIELD_STRUCT_DESC: 24-inch corrugated metal pipe through the levee, 7-feet below the crown. Flap gate on the waterward end. 5'X5' concrete control structure on LS toe. Originally included in O+M manual (1957). As-built drawings available 50-4-2394. FS Date: 10/2/2013

Pipe on WS toe with flapgate hinges.

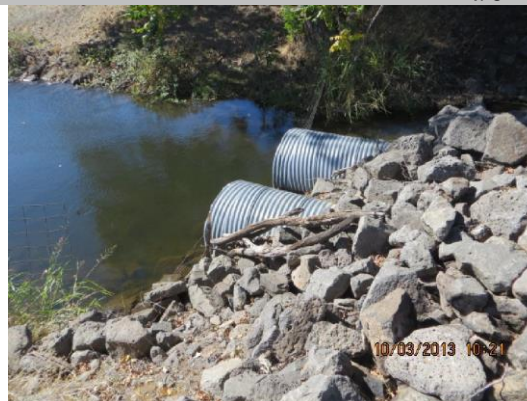
Photo 1 of 2 : UCIP_SP_2016_39836_39073.jpg

Pipe visible on LS toe.

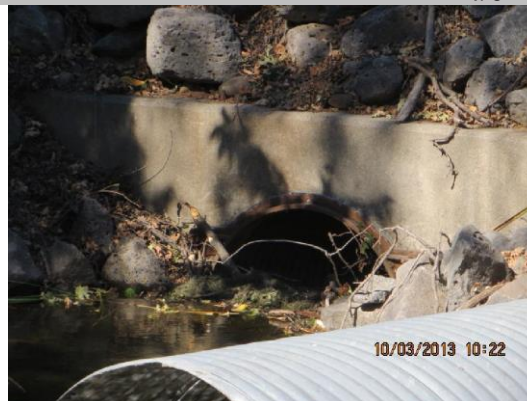
Photo 1 of 2 : UCIP_SP_2016_41126_39076.jpg

Pipe visible at headwall on LS toe.

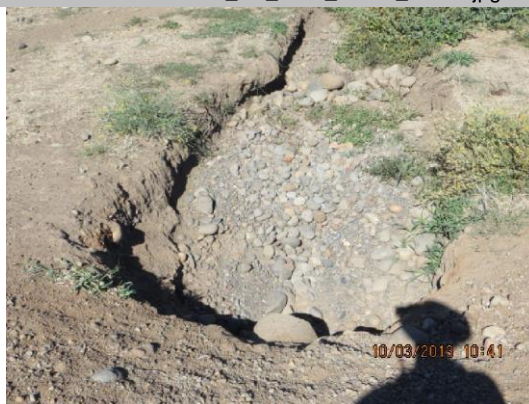
Photo 2 of 2 : UCIP_SP_2016_23094_39306.jpg

Concrete pipe at outlet on WS toe.

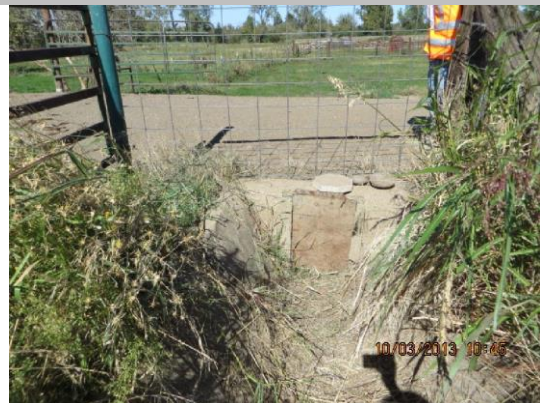
Photo 1 of 2 : UCIP_SP_2016_23092_39298.jpg

LM Start	3.75	Rating **	M	Issue No.	284
LM End	3.75	Issue Type +	En	Location *	CR
Category	Supplemental			GPS Latitude/Longitude	
				Start	End
Item	DWR UCIP Field Study			39.944426 °	39.944426 °
				-122.054045 °	-122.054045 °
DWR ID					
Comment Code					
Inspector Comment					
FS_ID:23092					
DS_ID:24691					
EP_NO: N/A					
Repair Type: Non-Urgent					
Crossing Status: Found					
UCIP Comments: Outlet substantially blocked at WS toe. No permit identified for this crossing.					
FIELD_STRUCT_DESC: 10-inch concrete irrigation pipe through the levee 2.0-feet below the crown. Slide gate at terminal end of concrete channel on LS shoulder.					
FS Date: 10/3/2013

Slide panel at inlet on LS shoulder.

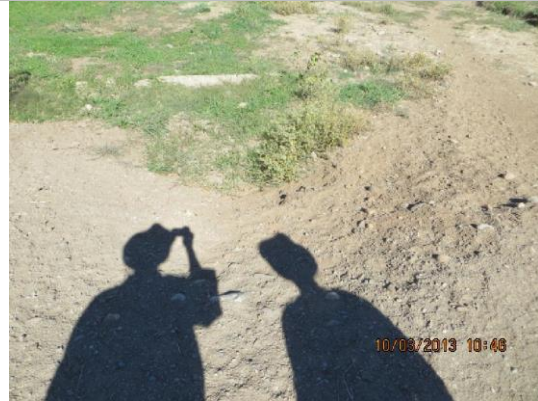
Photo 2 of 2 : UCIP_SP_2016_23092_39297.jpg

Pipe outlet on WS toe.

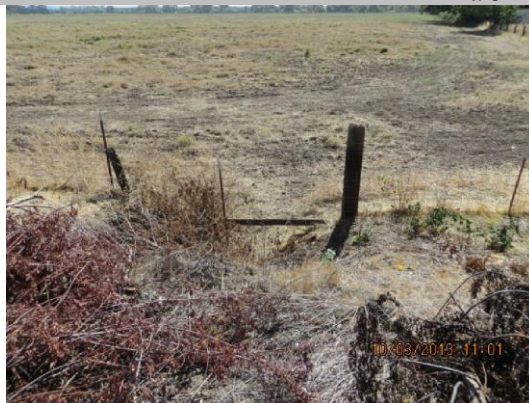
Photo 1 of 2 : UCIP_SP_2016_21743_36942.jpg

LM Start	4.10	Rating **	U	Issue No.	280
LM End	4.10	Issue Type +	En	Location *	WS
Category	Supplemental			GPS Latitude/Longitude	
				Start	End
Item	DWR UCIP Field Study			39.941002 °	39.941002 °
				-122.058711 °	-122.058711 °
DWR ID					
Comment Code					
Inspector Comment					
FS_ID:21743 DS_ID:20762 EP_NO: N/A Repair Type: Urgent Crossing Status: Found UCIP Comments: Gate missing from WS toe. FIELD_STRUCT_DESC: 24-inch CMP drain pipe through the levee 5.5- feet below the crown. Flap gate on the waterward end. Originally included in O+M manual (1957). As-built drawing No. 50-4-2394. FS Date: 10/3/2013

Inlet on LS toe.

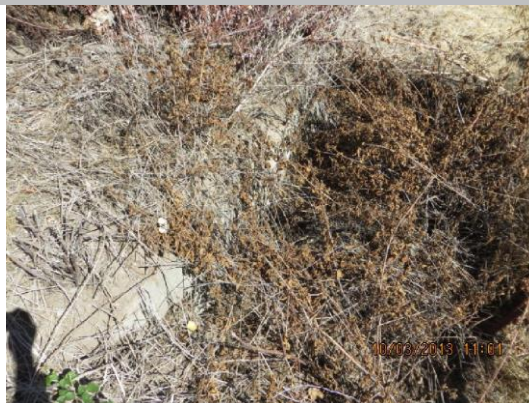
Photo 2 of 2 : UCIP_SP_2016_21743_36941.jpg

Concrete headwall at inlet on LS toe.

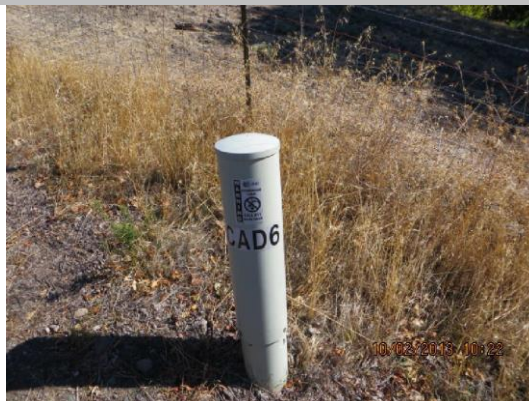
Photo 2 of 2 : UCIP_SP_2016_40789_39056.jpg

Communication line access box on WS shoulder.

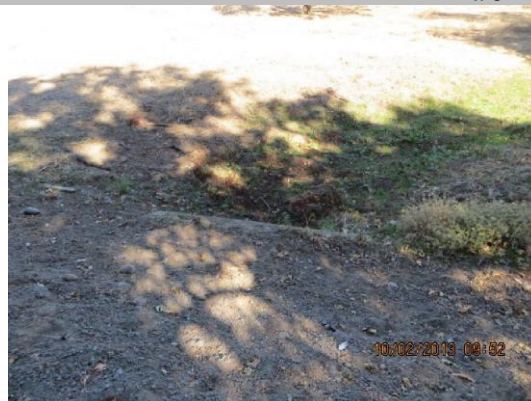
Photo 1 of 2 : UCIP_SP_2016_41123_36902.jpg

Concrete headwall at LS toe.

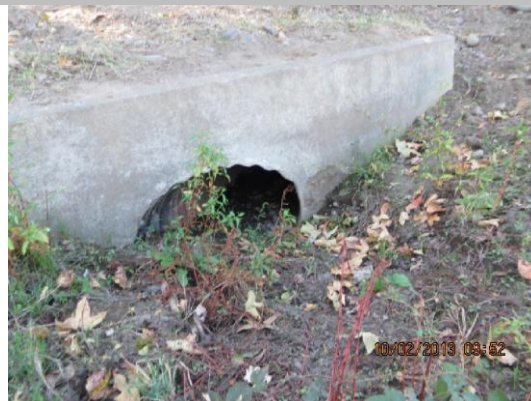
Photo 2 of 2 : UCIP_SP_2016_41123_36901.jpg

Concrete headwall at LS toe.

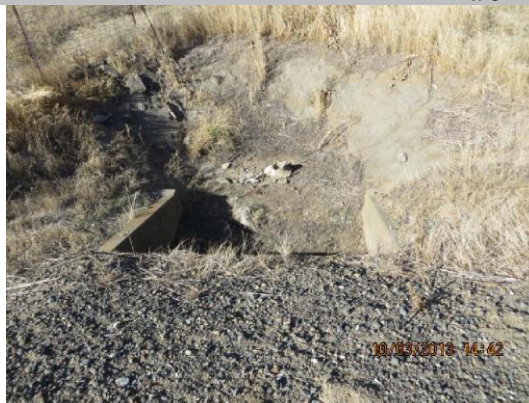
Photo 1 of 2 : UCIP_SP_2016_41125_37061.jpg

Concrete U-shaped headwall on LS toe.

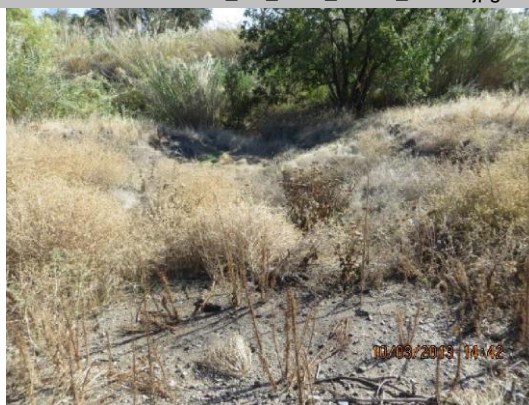
Photo 2 of 2 : UCIP_SP_2016_41125_37060.jpg

Concrete U-shaped headwall on WS toe.

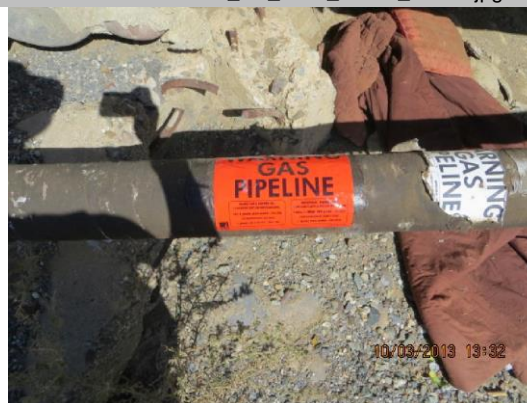
Photo 2 of 2 : UCIP_SP_2016_23045_39105.jpg

LM Start	2.28	Rating **	M	Issue No.	917 (cont)
LM End	2.28	Issue Type +	En	Location *	WS
Category	Supplemental			GPS Latitude/Longitude	
				Start	End
Item	DWR UCIP Field Study			40.052379 °	40.052379 °
				-122.149534 °	-122.149534 °
DWR ID					
Comment Code					
Inspector Comment					
FS_ID:23045 DS_ID:24694 EP_NO: N/A Repair Type: Non-Urgent Crossing Status: Found UCIP Comments: No permit identified for this crossing. FIELD_STRUCT_DESC: 4-inch gasline through the levee 3.5-feet below the crown. Pipe visible on upstream side of bridge. FS Date: 10/3/2013

Gasline on upstream side of bridge.

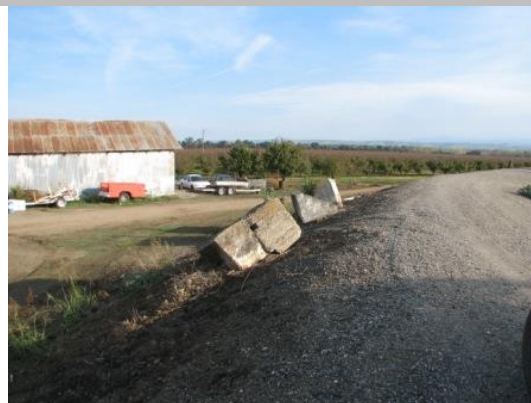
Photo 1 of 1 : SP_2016_NA0019_81_1_20160316_00001.jpg

LM Start	3.13	Rating **	M	Issue No.	1
LM End	3.13	Issue Type +	Ma	Location *	LS
Category	Earthen Levee			GPS Latitude/Longitude	
				Start	End
Item	Encroachments			40.057285 °	40.057285 °
				-122.137732 °	-122.137732 °
DWR ID	DWR_NA0019_04_s_2012_1				
Comment Code					
ST : Stairway					
Inspector Comment					
Remove concnere blocks, concrete pipes and concrete stairs from the landside slope.

View of the concrete stairways on the slope.

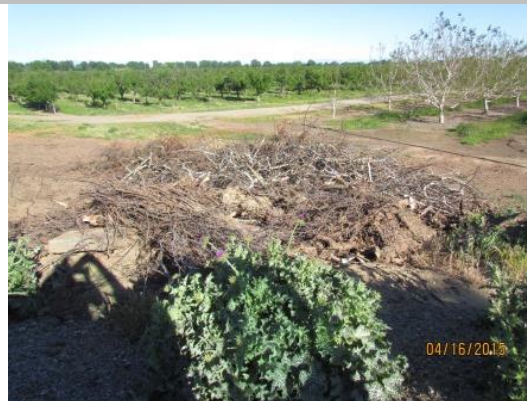
Photo 1 of 1 : SP_2016_NA0019_81_21_20160316_00016.jpg

LM Start	3.66	Rating **	M	Issue No.	21
LM End	3.66	Issue Type +	En	Location *	LS
Category	Earthen Levee			GPS Latitude/Longitude	
				Start	End
Item	Encroachments			40.055735 °	40.055735 °
				-122.129445 °	-122.129445 °
DWR ID	DWR_NA0019_04_s_2015_21				
Comment Code					
PR : Prunings					
Inspector Comment					
Remove the prunings from the landside toe.

View of the prunings along landside toe.

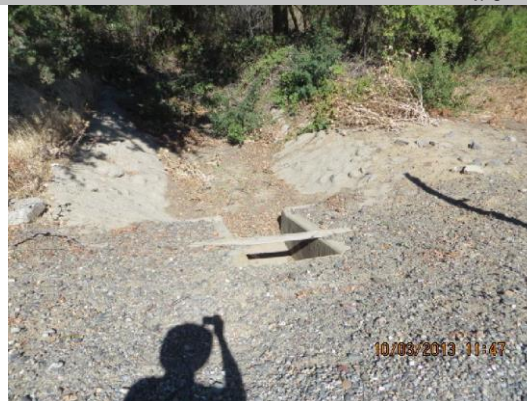
Photo 1 of 2 : UCIP_SP_2016_41124_36953.jpg

Concrete headwall on WS toe.

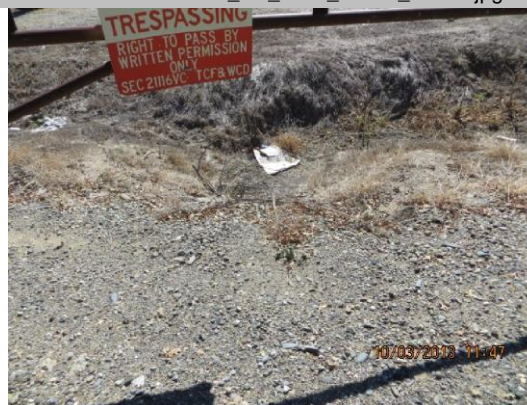
Photo 2 of 2 : UCIP_SP_2016_41124_36952.jpg

Inlet at LS toe.

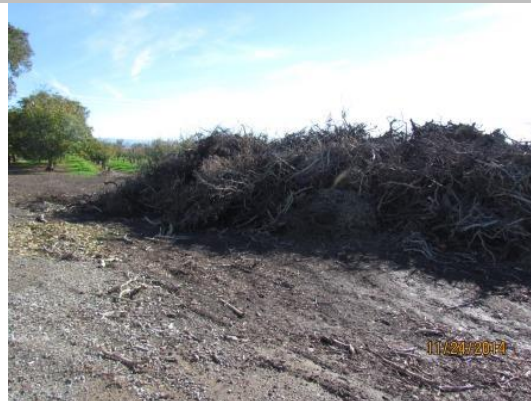
Photo 1 of 2 : SP_2016_NA0019_82_16_20160316_00006.jpg

View of the prunings along the landside slope.

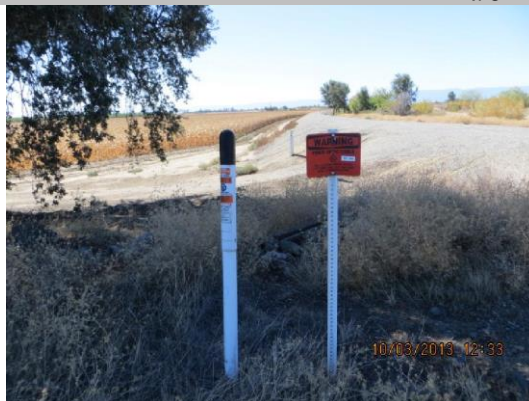
Photo 1 of 2 : UCIP_SP_2016_23052_39137.jpg

Fiber optic line markers on LS shoulder.

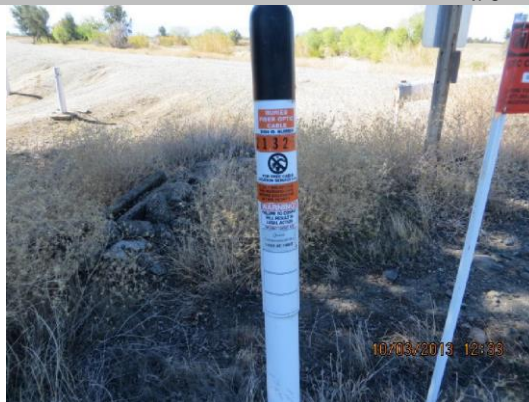
Photo 2 of 2 : UCIP_SP_2016_23052_39136.jpg

Fiber optic line markers on LS shoulder.

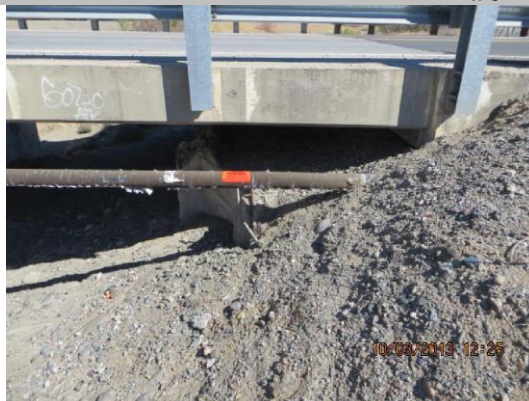
Photo 1 of 2 : UCIP_SP_2016_23044_39104.jpg

Gasline on upstream side of bridge.

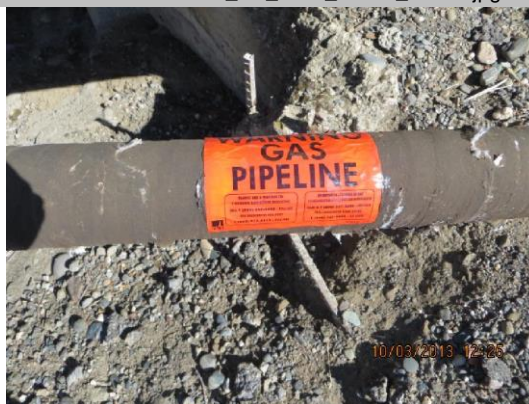
Photo 2 of 2 : UCIP_SP_2016_23044_39103.jpg

Gasline on upstream side of bridge.
